Zlin Aviation S.R.O.

Safety Alert	Nº01	13 December 2006
---------------------	-------------	-------------------------

- **Airplanes affected:**
all Savage Aircrafts and models
- **Subject:**
New cables and Pulleys for Vertical Tail
- **Reason:**

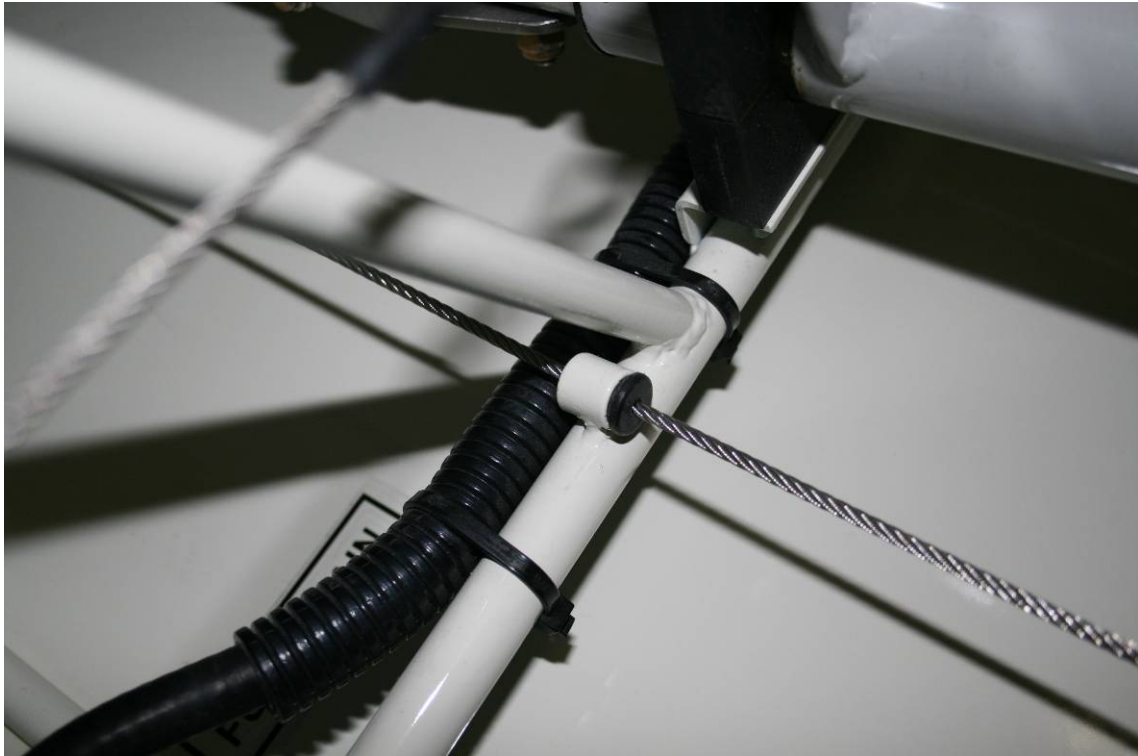
Picture 1: steel bushing to be cutted

To ensure the assembling of the new two cables and their plastic bushings into the frame of the fuselage (see the pictures) it is necessary to cut the small steel tube on the bottom of the fuselage behind the rear seat, two times about 3,2 mm apart, stretch out a little and insert the bushing and draw back. A visual control of the alignment of the cables with the pulleys *has to be made*. It is possible to correct the alignment eventually screwing the steel plate of the cable, inside the rear pedals and not outside like usually is done. Bending “*just*” a little this steel plate is also an alternative.

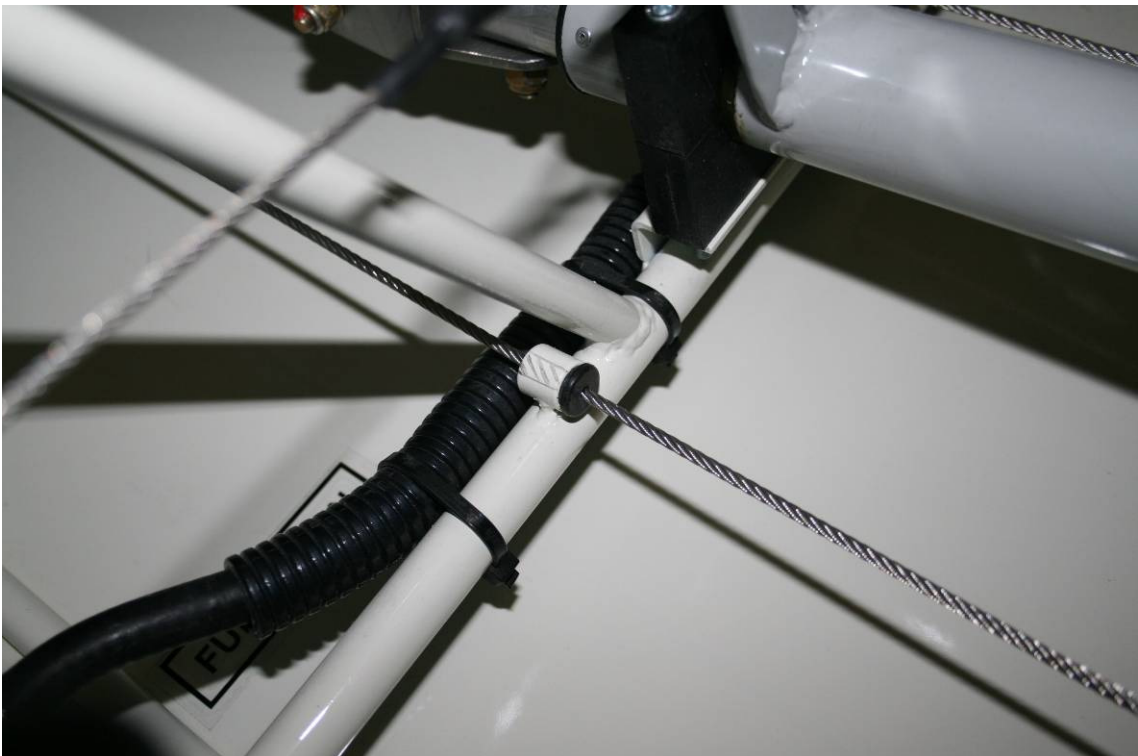
Picture 2: material to be removed, at least 3,2mm wide.

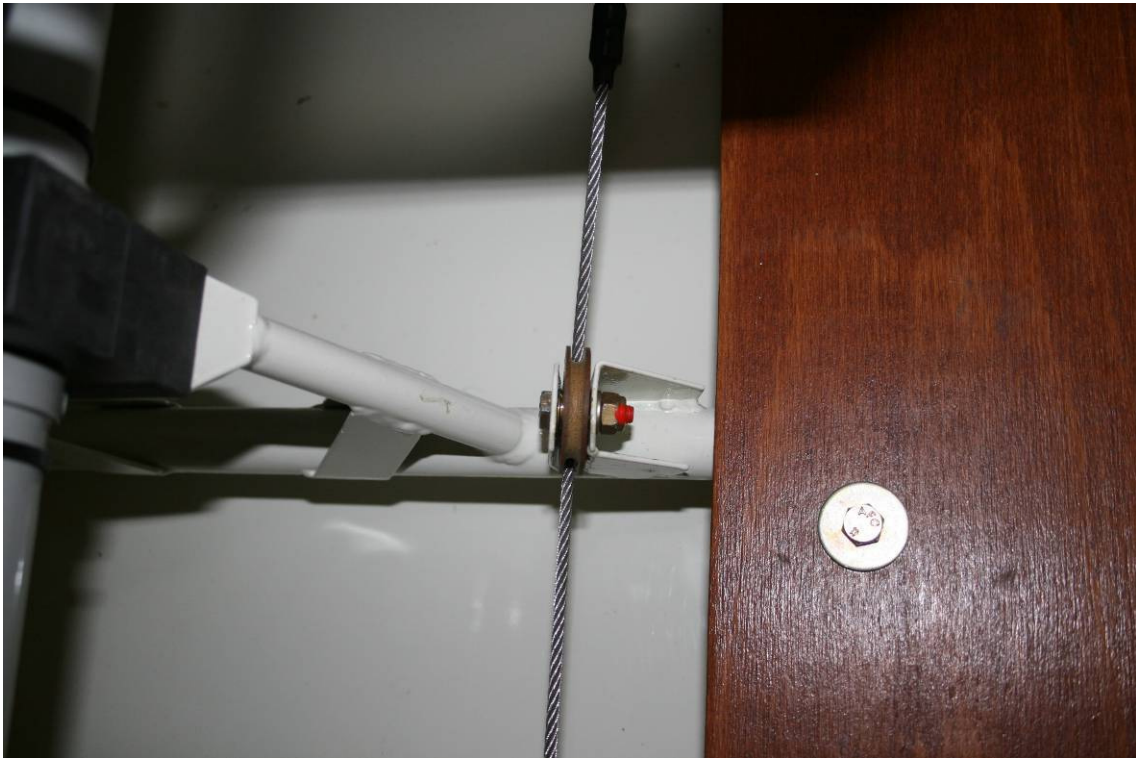
Picture 3: visual control of correct alignment.

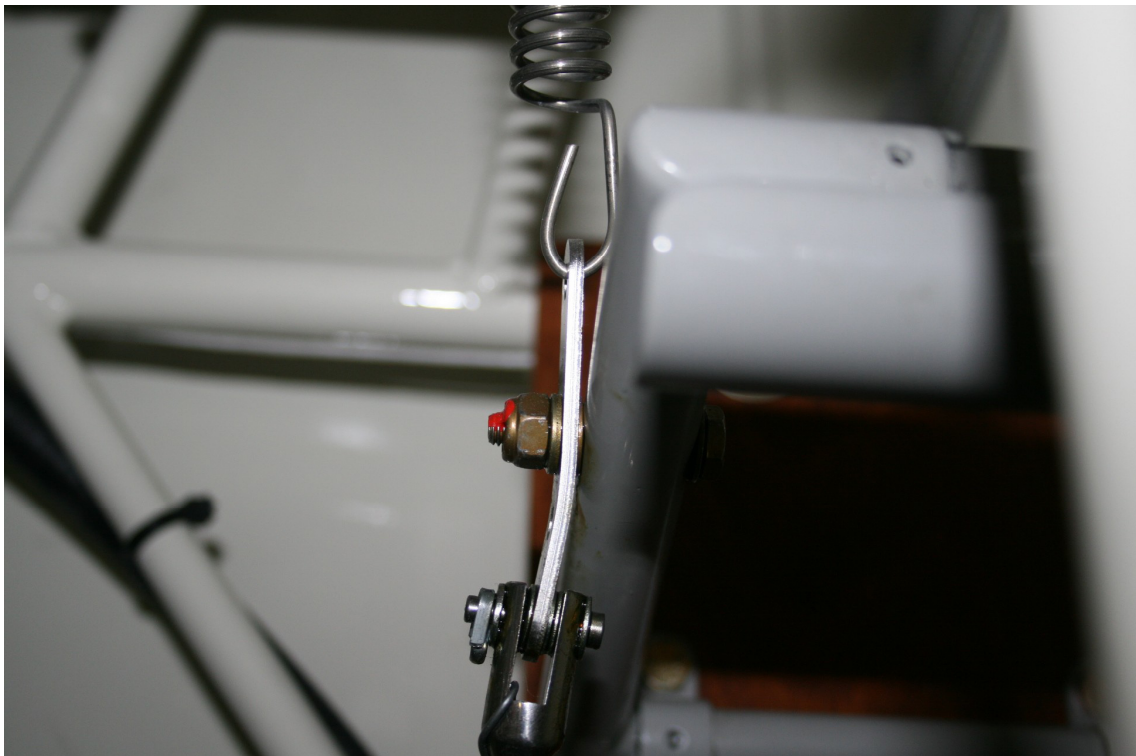
Picture 5: normal position of steel plate.

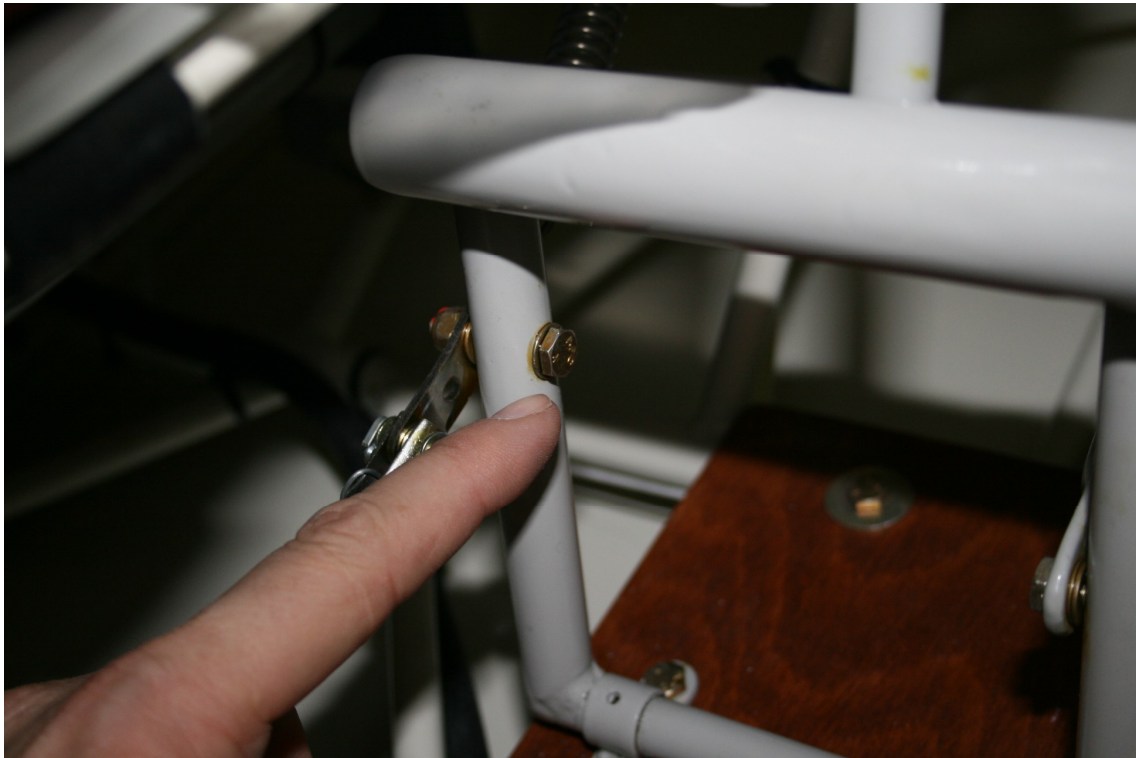
Picture 6: new steel position allowed for improved cable alignment.
